Navajo Abandoned Uranium Mine

Site Screen Report

Mine Name: Harvey Blackwater No. 1
Mine ID: 700

April 2012

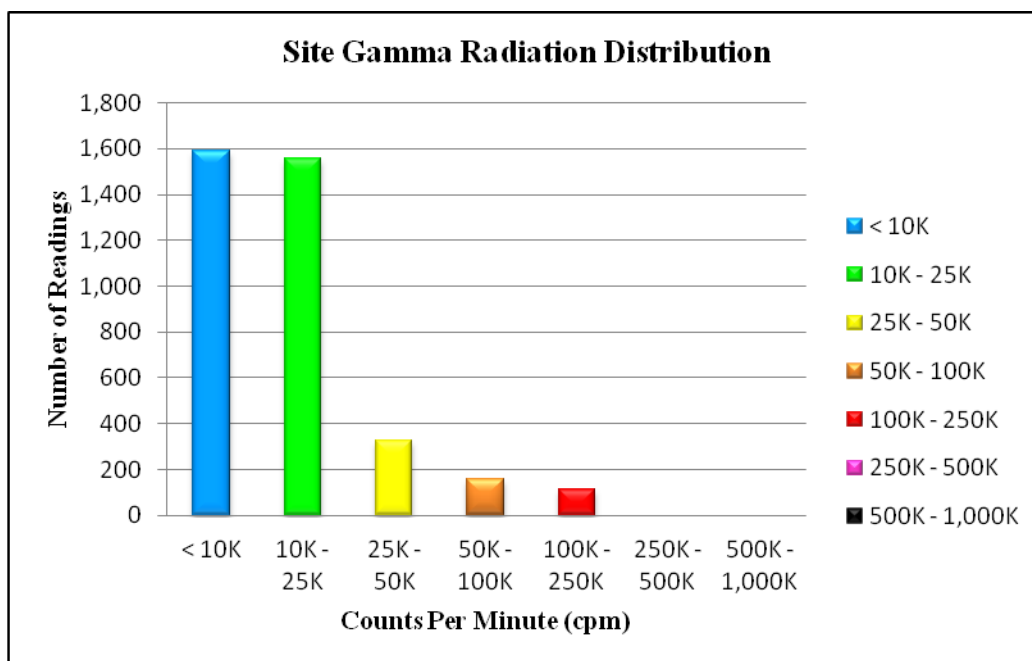
Site Gamma Radiation Statistics	
Number of Readings	3,753
Minimum (cpm)	4,846
Maximum (cpm)	236,923
Mean (cpm)	20,073
Median (cpm)	11,282
Standard Deviation	27,058

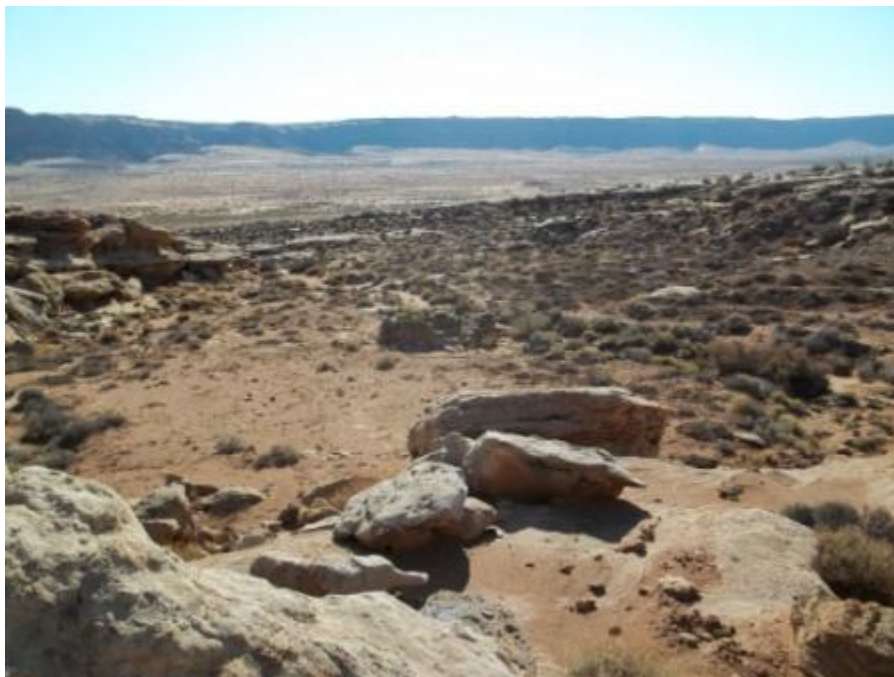
Photo 1

0 to 200 feet: Onsite - Stone hogan in center of site, with no roof

Hogan - 30,000 cpm

Mine Site #700 - Hogan

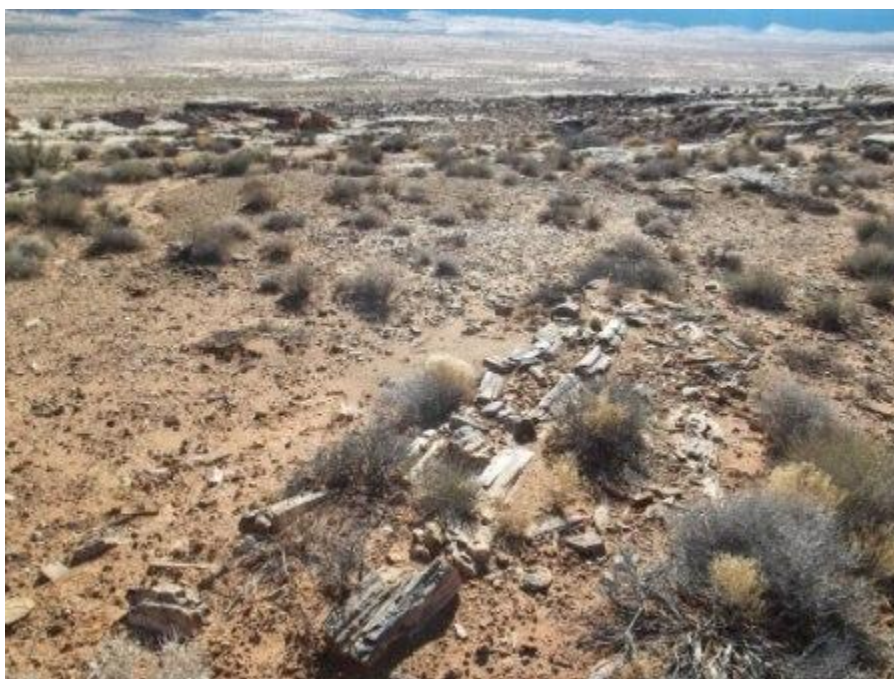
Photo 2

Mine Site #700 – Petrified log

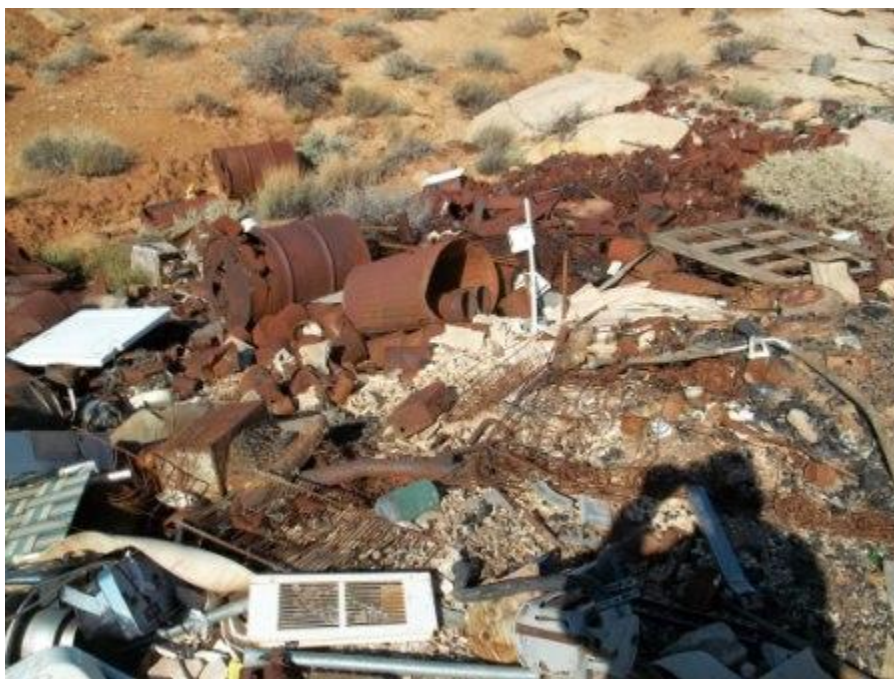
Photo 3

Household dump area immediately north of the site; exploratory borings in the northern part of the site

Mine Site #700 – Dump area

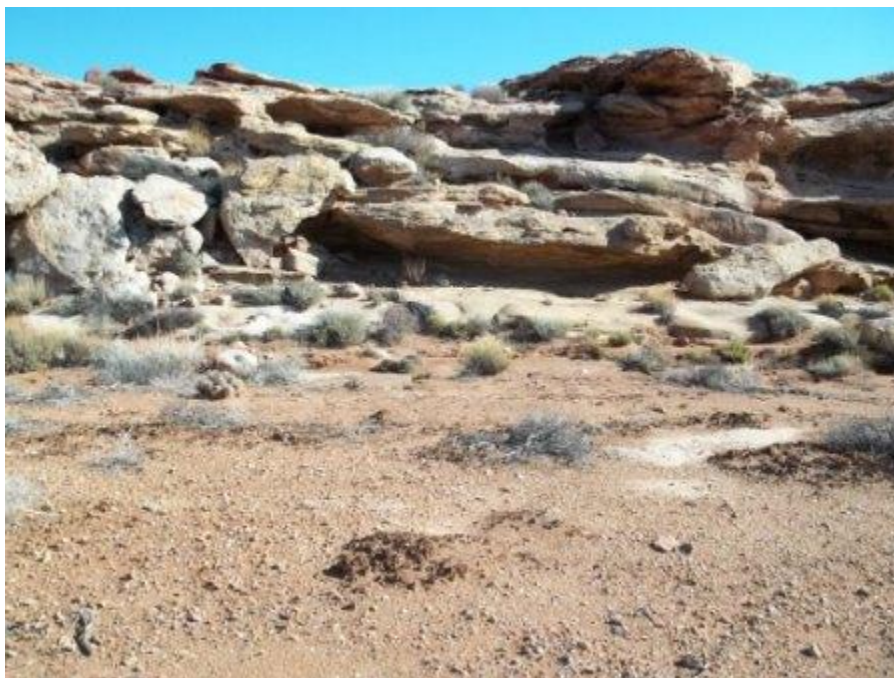
Photo 6

Highest gamma radiation measurement: 236,923 counts per minute (cpm)

Mine Site #700 – Elevated gamma readings

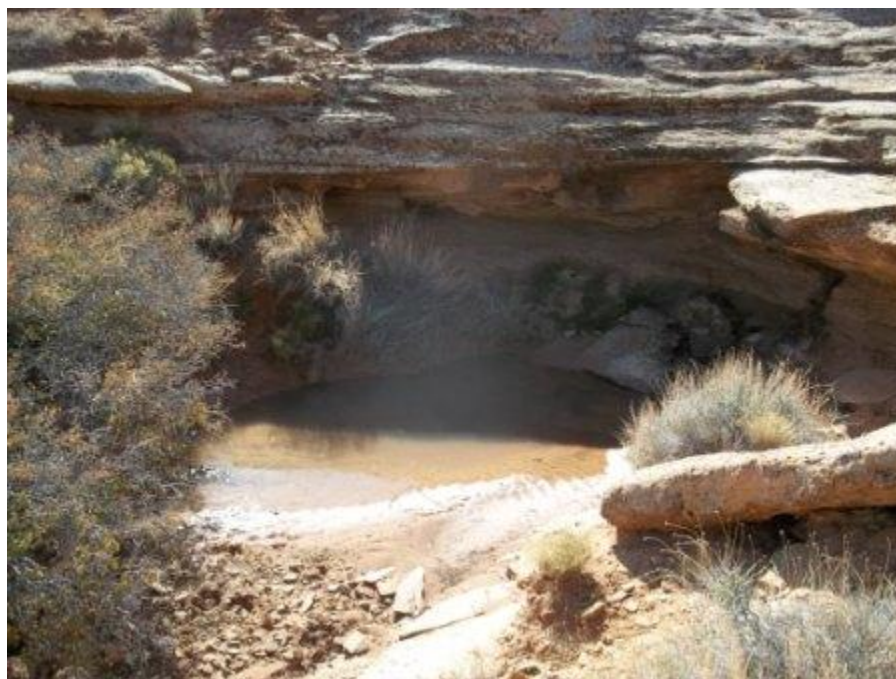
Photo 7

0 to 0.25 miles: Onsite - Pond (700)

Mine Site #700 - Pond

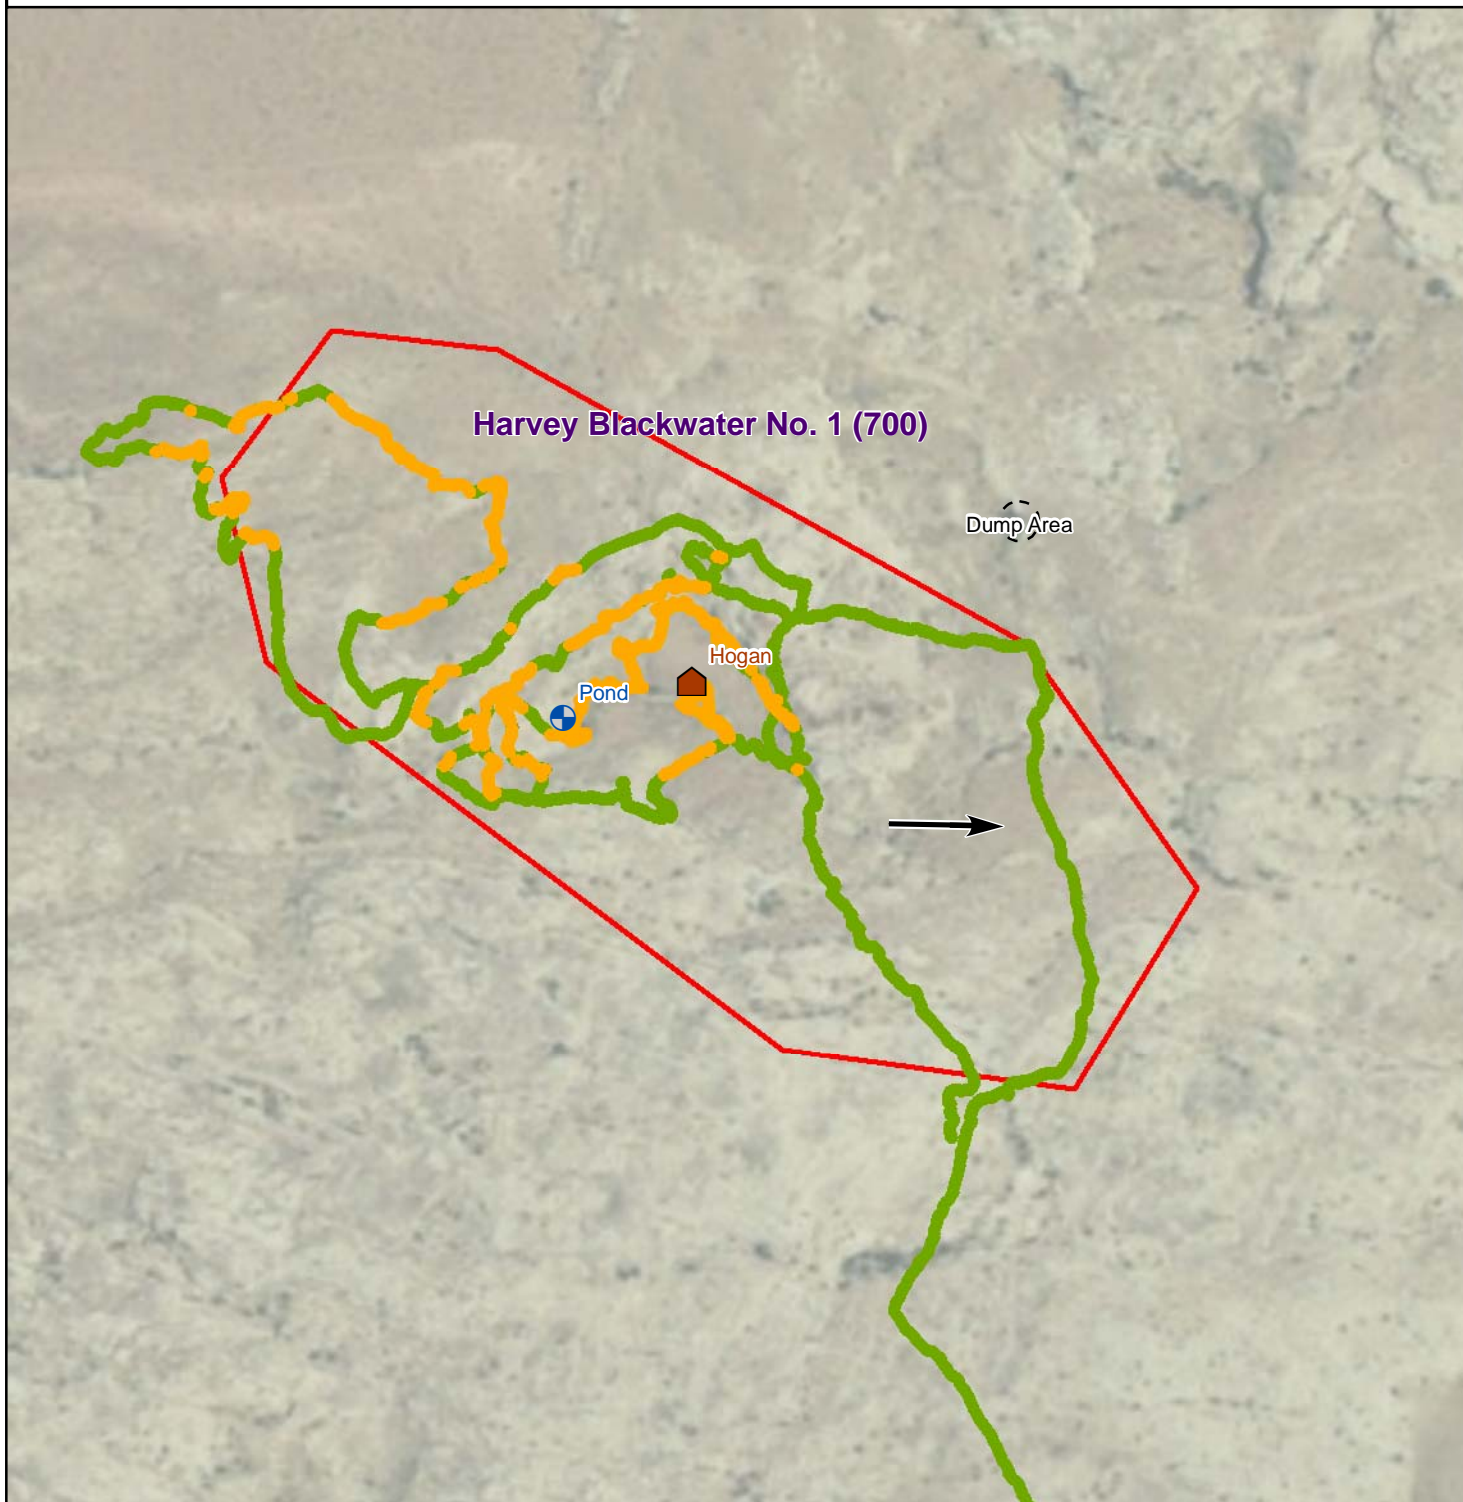
**Figure 1 - Gamma Radiation Measurements, Above Two Times Background
Harvey Blackwater No. 1 (700)
Kayenta Chapter, Navajo Nation**

A total of 3,753 gamma radiation measurements were collected from the mine site, ranging from 4,846 cpm to 236,923 cpm. The measurements are represented in Figures 1 and 2.

Average background 7,408 cpm

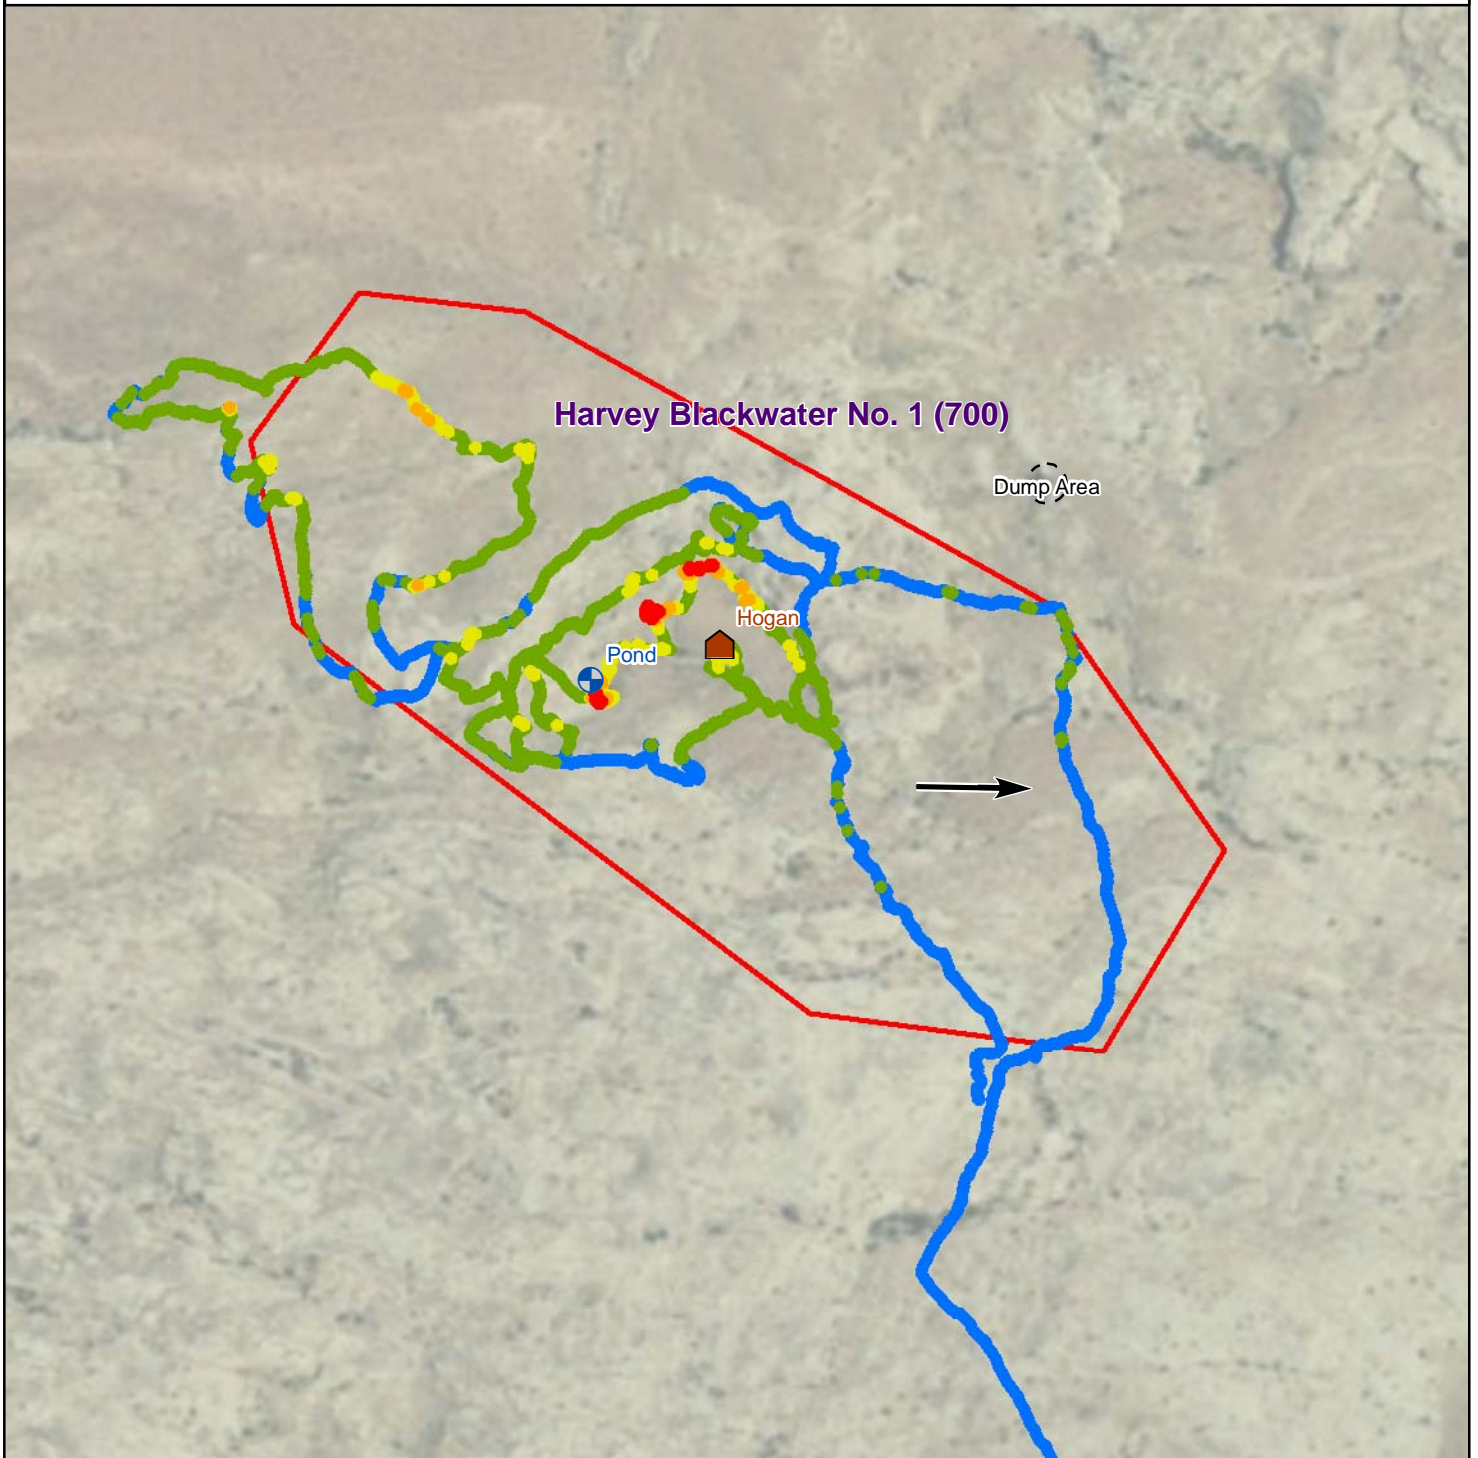
**Figure 2 - Gamma Radiation Measurements
Harvey Blackwater No. 1 (700)
Kayenta Chapter, Navajo Nation**

Average background 7,408 cpm
